The Friends of Hunting Creek (FOHC) completed our third Water Quality Blitz on April 1, 2023. We collected water samples in 11 catchments across almost the entire watershed. To assist our ongoing efforts to get “up close and personal” with the 50+ miles of streams that drain the 19,127-acre Hunting Creek watershed of Calvert County, Maryland, we have unofficially named several previously unnamed tributaries (see Figure 1.1). In addition to measuring nitrogen, phosphorus, and turbidity at 21 sites, we also sampled benthic macroinvertebrates (macros) and collected environmental DNA (eDNA) samples in four streams.

**Figure 1.1** Map with both official (light blue) and unofficial (dark blue) names of Hunting Creek streams.

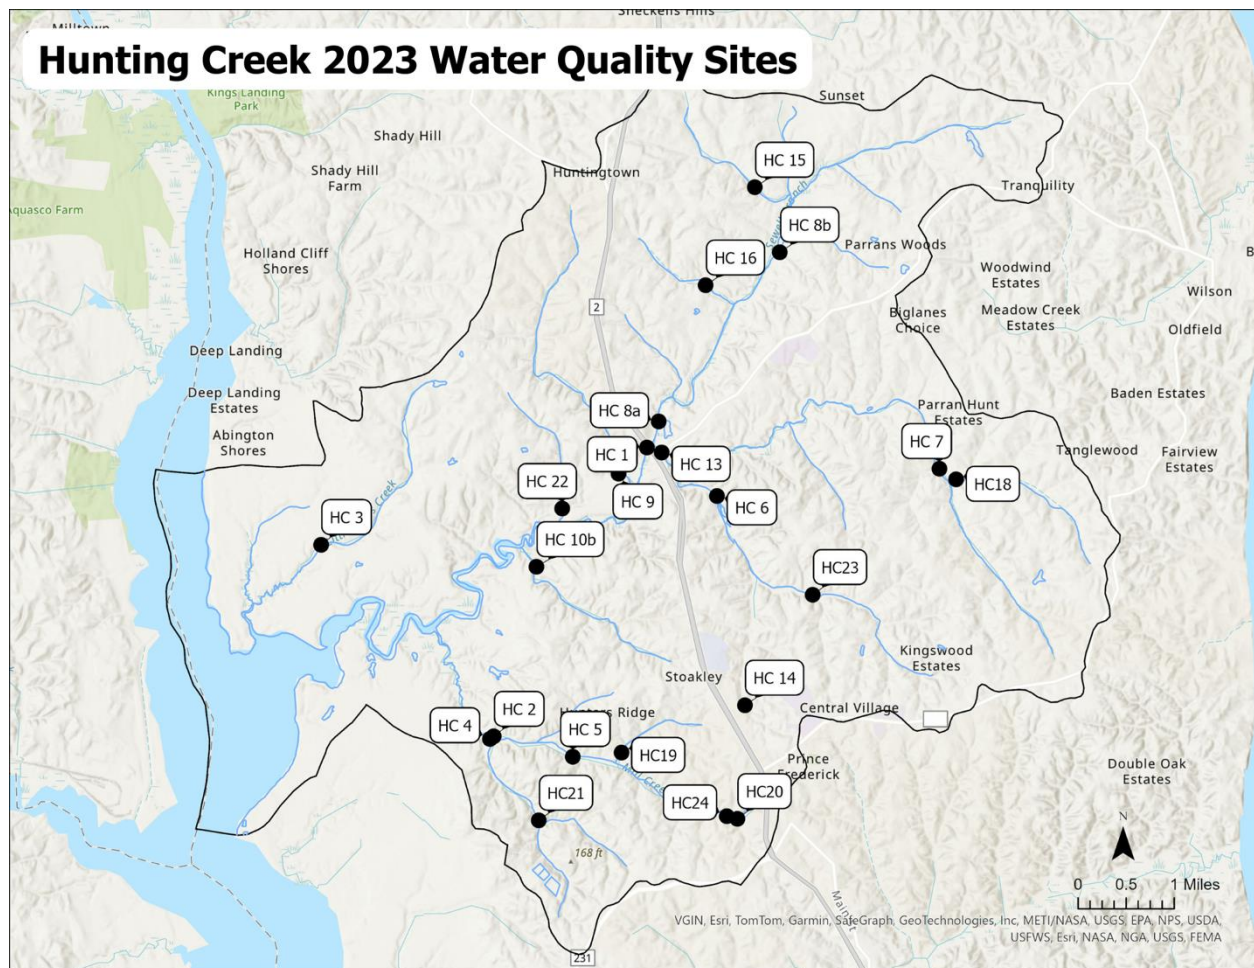
Figure 3.1

Two grab water samples were collected at each of the 21 stream sites by FOHC volunteers in the morning of April 1, 2023 (Figure 3.1). Water samples were transported to ACLT headquarters in insulated coolers with ice. Those samples destined for measurements of NO<sub>3</sub> and PO<sub>4</sub> at the Nutrient Analytical Services Laboratory, Chesapeake Biological Laboratory, Solomons MD, were filtered at ACT within 2-4 hours after collection. The filtrates were frozen and transported to CBL. The other water samples were analyzed for turbidity by FOHC volunteers at ACLT using an Apera TN400 Meter.

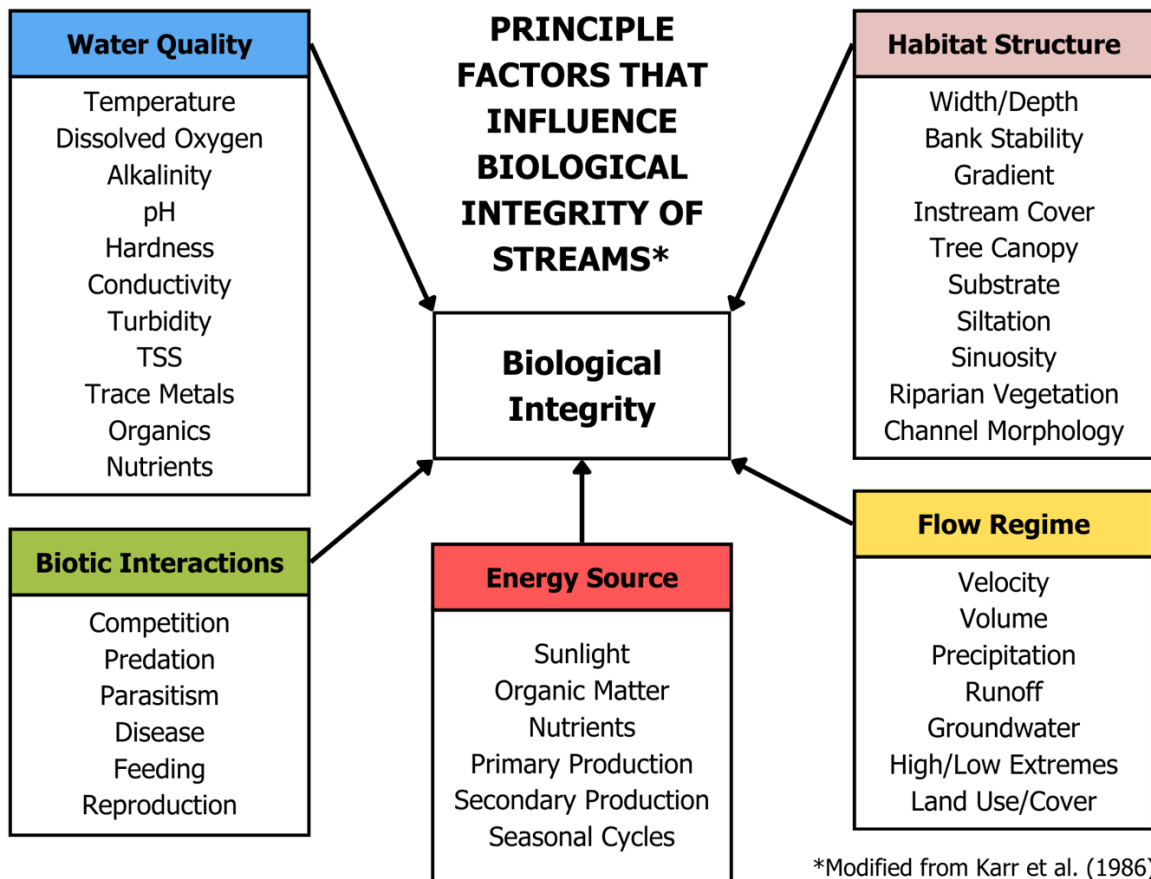
**Figure 3.2**

BIBI scores calculated from macros data are useful for distinguishing degraded from healthy streams. The integrity of macros communities (and other aquatic biota) is influenced by many factors (Figure 3.2). Therefore, identifying the specific stressors that are impacting macros in degraded streams is challenging.

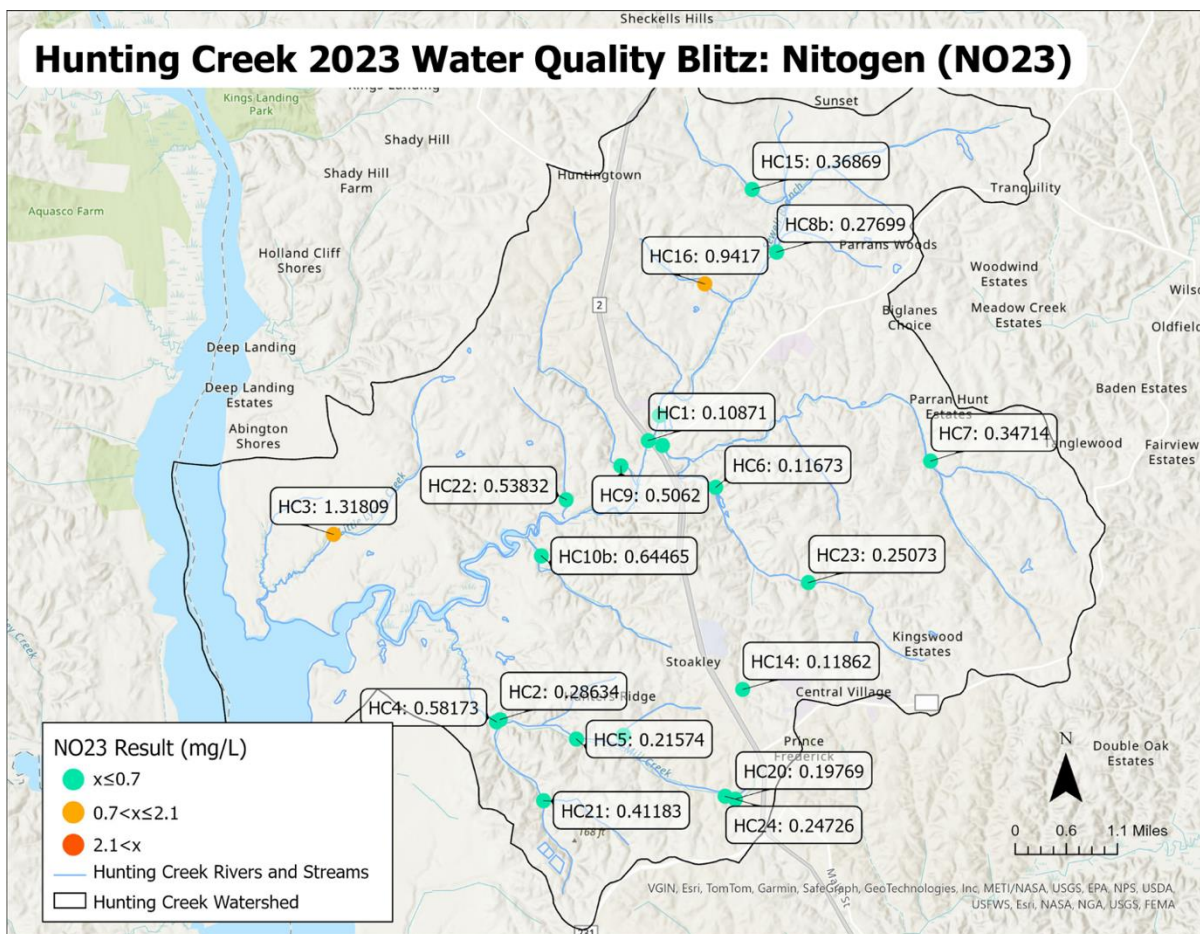
Figure 4.1

The American Chestnut Land Trust uses 0.7 and 2.1 mg/L as the upper thresholds of the *Good* and *Fair* NO<sub>2</sub>3 categories, respectively. These categories have changed since 2021, which had 0.7 and 1.05 mg/L as the upper thresholds for the *Good* and *Fair* categories, respectively. Overall, 90.5% of the sites tested in 2023 had *Good* NO<sub>2</sub>3 concentrations, while the remaining 9.5% of sites had *Fair* NO<sub>2</sub>3 concentrations. Compared across the three years of FOHC participation in the Water Quality Blitz, 2023 had the highest percentage of *Good* sites, as shown in figure 4.2. It is noteworthy, however, that the number of sites has increased from 10 sites in 2021 to 17 sites in 2022 to 21 sites in 2023. Although the number of sampled sites increased, the number of sites exhibiting elevated NO<sub>2</sub>3 concentrations showed little change (3 in 2021, 3 in 2022, and 2 in 2023).

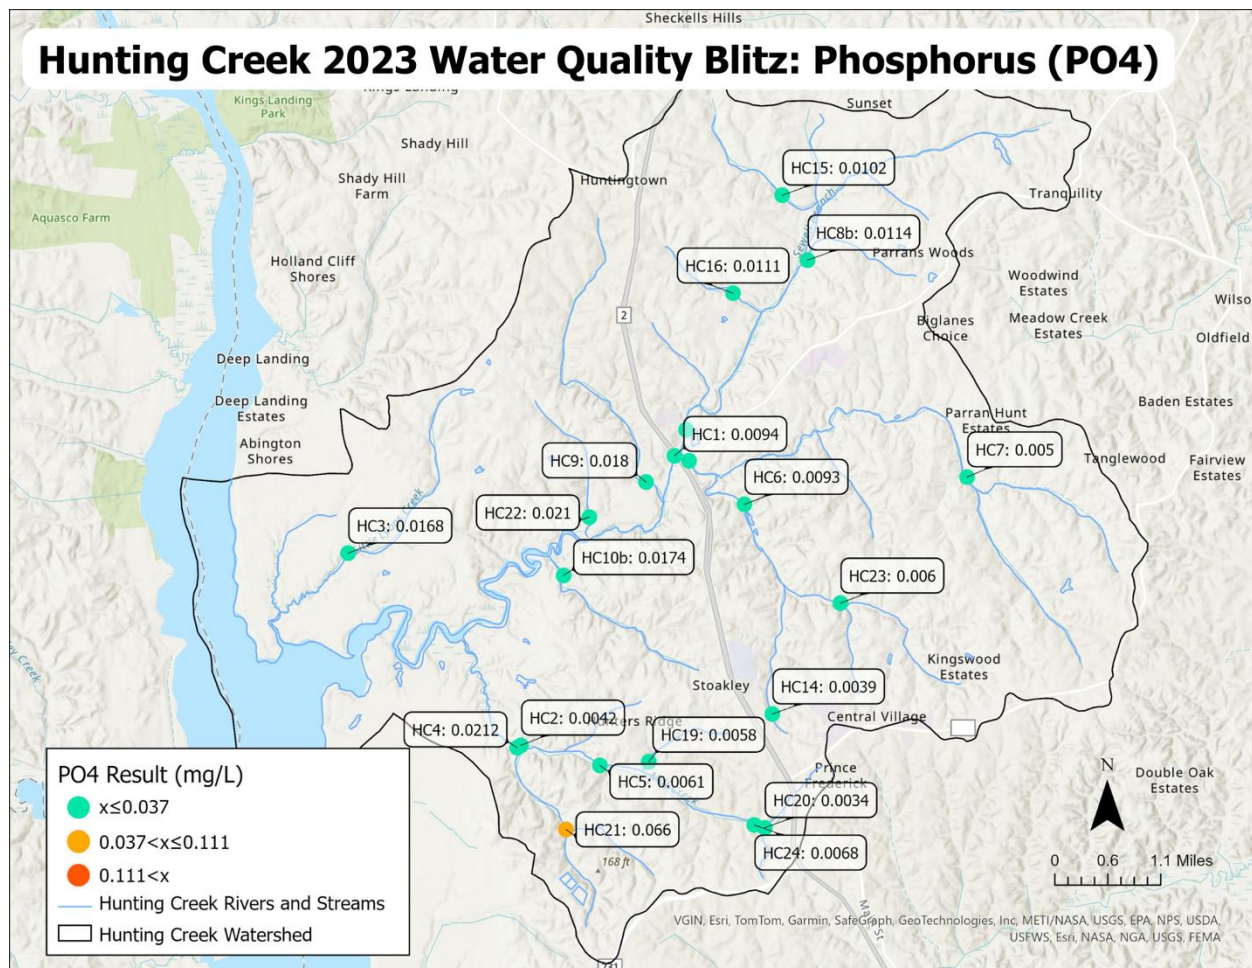
Figure 4.3

Phosphorus (PO<sub>4</sub>) levels in the Hunting Creek watershed were overall *Good* in 2023. As depicted in Figure 3.4, only one out of 21 sites exhibited elevated PO<sub>4</sub> concentrations. Site HC21 had phosphorus levels within the *Fair* threshold, between 0.037 and 0.111 mg/L.

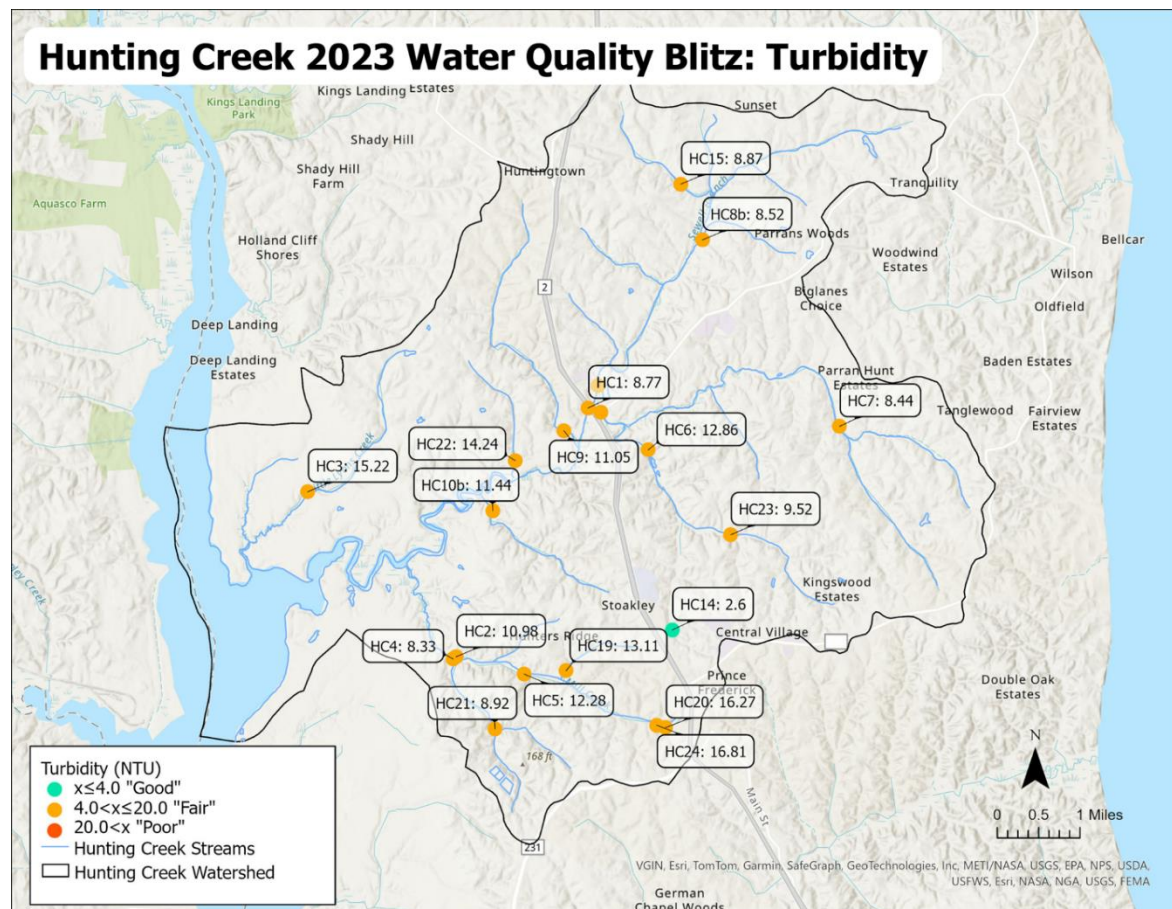
**Figure 4.4**

Turbidity measurements were made on water samples collected on April 1, 2023, during baseflow conditions, at the 21 Blitz sites across the Hunting Creek watershed. Turbidities varied from a low of 2.6 Nephelometric turbidity units or NTUs (*Good* condition) at HC14 to a high of 22.1 NTUs (*Poor* condition) at HC16, with turbidities at the other 20 sites in the *Fair* condition range (Figure 4.4). The full set of turbidity data is

Turbidity is a measure of the cloudiness or haziness of a water sample caused by suspended particles that are usually not visible to the naked eye. Elevated turbidities that persist in streams for more than a few hours can harm macros, fish, and other aquatic organisms via mechanical damage to gills, smothering eggs and developing larvae, making food gathering more difficult, altering dissolved oxygen levels, and temperature-related impacts. Most macros and fish function optimally at turbidity levels below 10 NTUs. Chronic, several-day exposures to turbidity levels above 20-25 NTUs are generally problematic for macros, fish, and aquatic plants. High turbidity levels, short-term and continuous, indicate that sediments and probably nutrients, organic contaminants, heavy metals, and other pollutants are being transported downstream. The turbidity levels shown in Figure 4.4 were measured in water samples collected during baseflow conditions when turbidities should be at their lowest levels and what the aquatic organisms living in those streams regularly experience and are adapted to. As mentioned above, baseflow conditions are defined as “no measurable rainfall amount during 48-72 hours preceding water sample collection.”

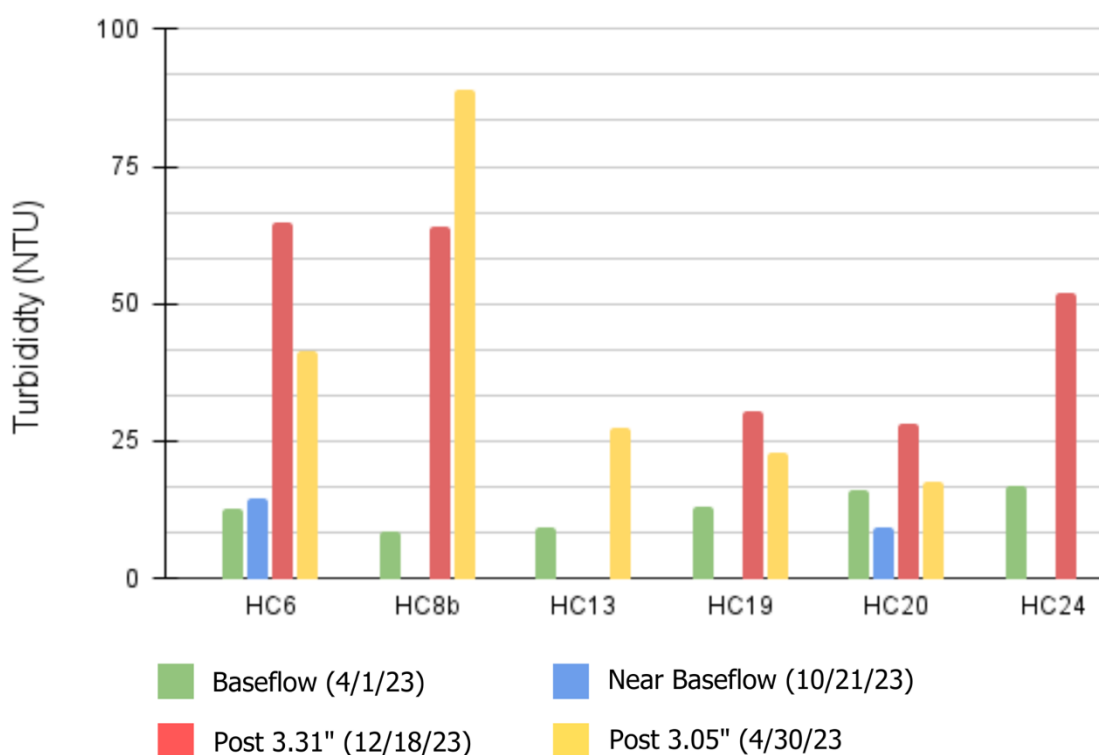
**Figure 4.5**

FOHC volunteers also measured turbidity at six sites in the Hunting Creek watershed immediately after above average rainfall events in 2023: 3.05 in. on 4/1/23 and 3.31 in. on 12/18/23. As shown in Figure 4.5, stream turbidity increased by a factor of only 1 at HC20, compared to baseflow levels, but by a factor of 10.5 (to 88.9 NTUs) at HC8b. Turbidity levels in the 50 to almost 90 NTUs range that persist for more than a day or two would almost certainly be detrimental to aquatic organisms exposed to these conditions.

### **Stream Turbidities at Baseflow and After Rain Events, Hunting Creek Watershed, 2023**

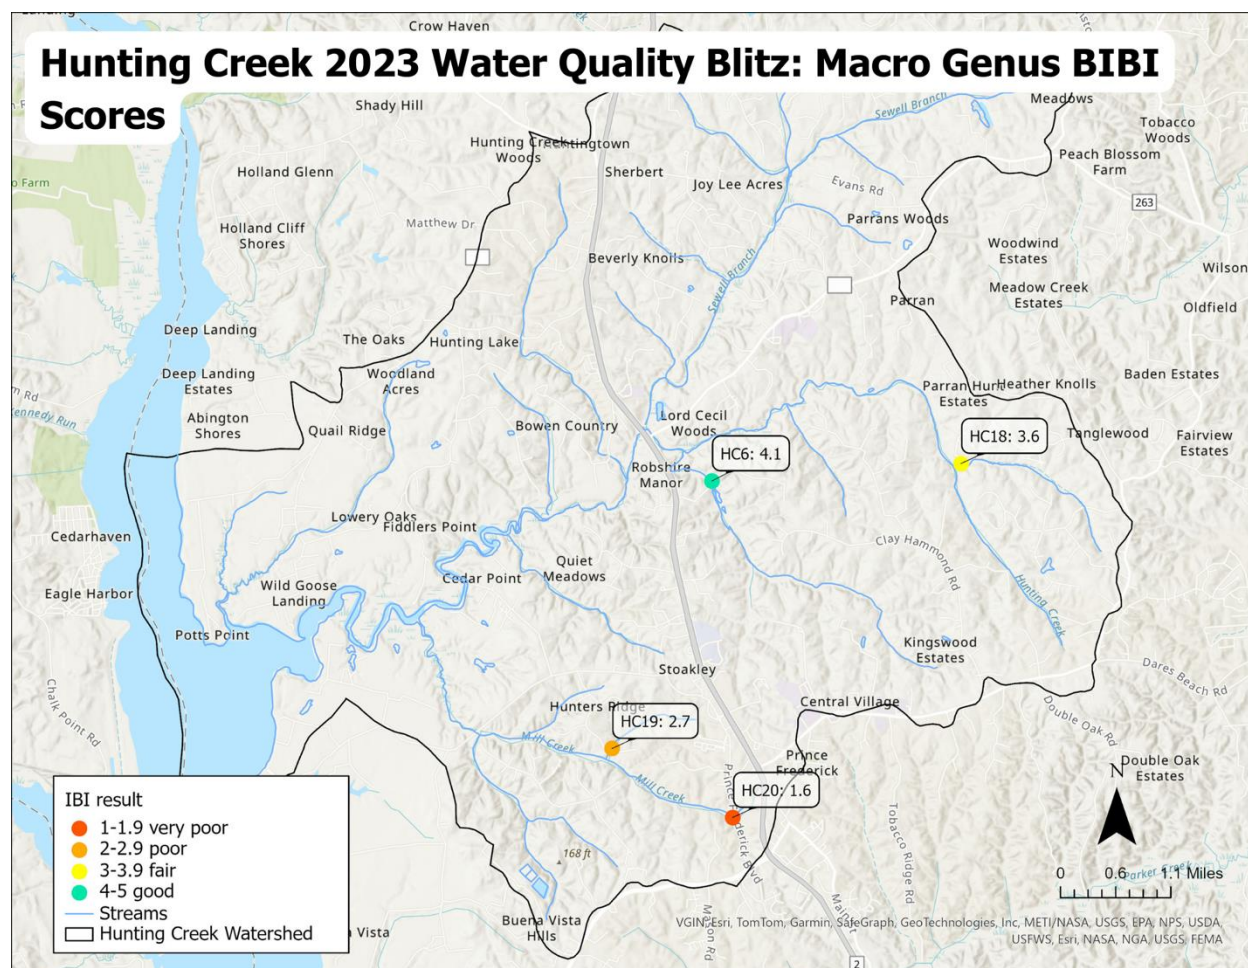
Figure 4.6

Genus-level BIBI scores calculated from D-net sample collections for each of the four stream sites sampled in 2023 ranged from a low of 1.6 (very poor) at HC20 to a high of 4.1 (good) at HC6 (Figure 4.6). BIBI scores in 2023 increased at one of the two sites where macros were also sampled by FOHC volunteers in 2022. The BIBI score at HC18 increased from 2.71 (poor) in 2022 to 3.6 (fair) in 2023. However, at HC19, the BIBI score in 2023 was unchanged from 2022 (2.7, poor).

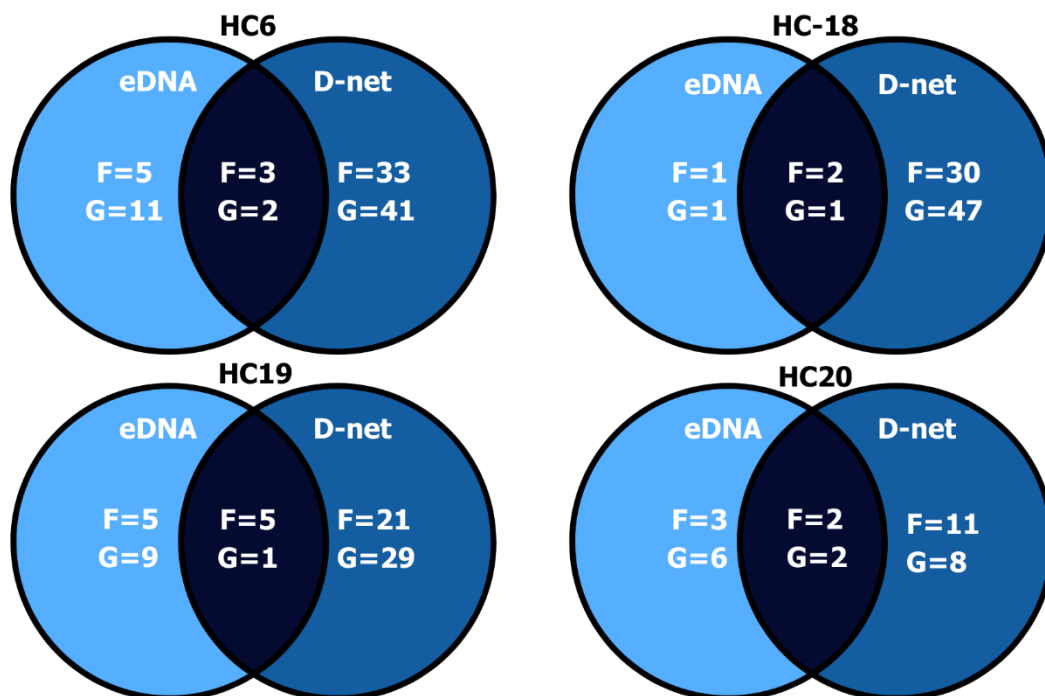
Figure 4.8

**Number of Macros Families (F) and Genera (G) Revealed by D-net and eDNA Sampling at Four Pilot Study Sites, Hunting Creek Watershed, 2023\***

\*Numbers of families and genera in the overlap (shared) areas are similar and were found by both sampling methods.

\*Numbers of families and genera in the non-overlap areas are unique to that sampling method.

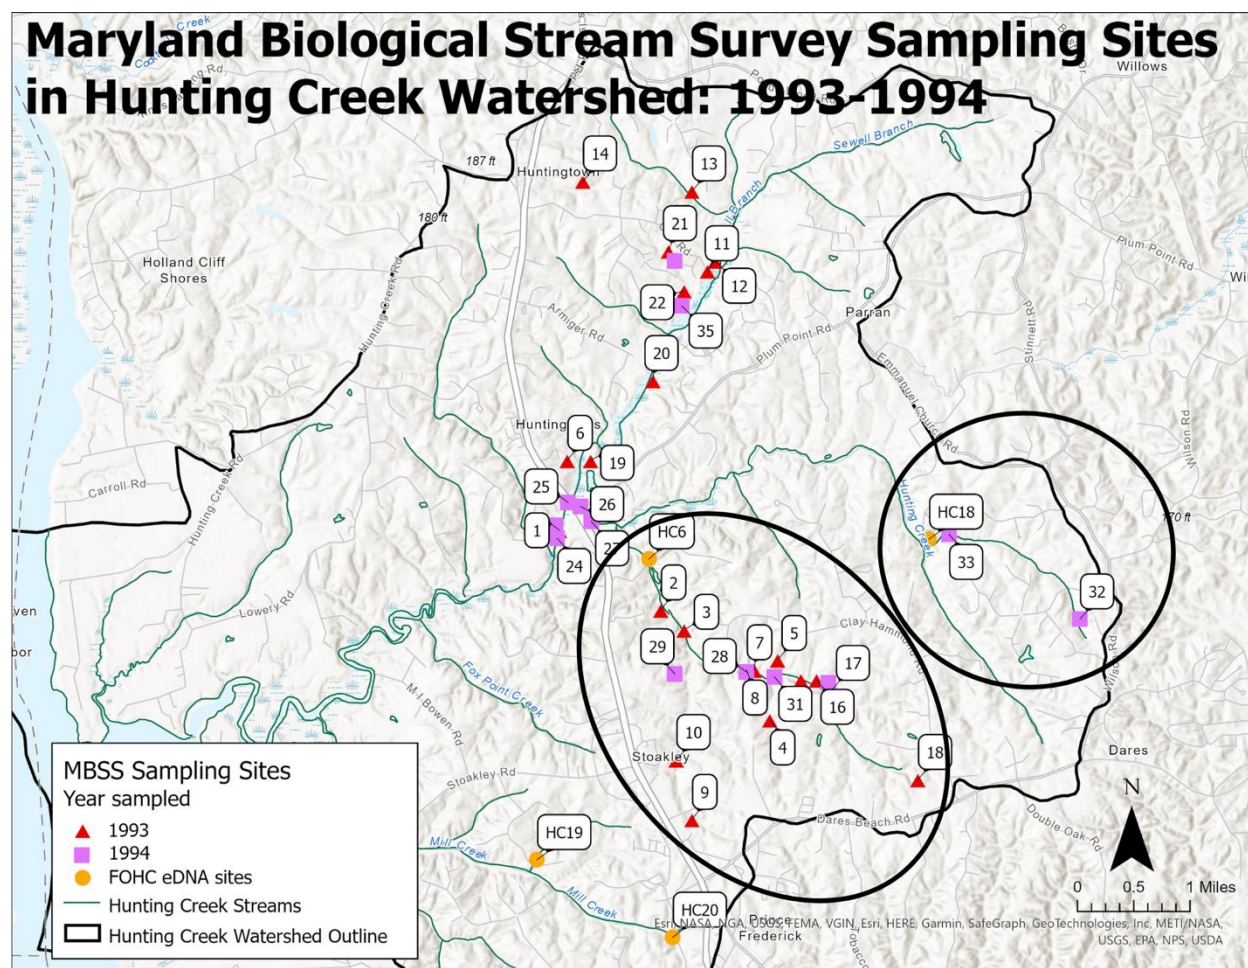
#### Figure 4.9

However, during MD/DNR’s 1993 and 1994 MBSS Pilot Studies, they sampled 31 sites throughout the Hunting Creek watershed (Figure 4.9). Fortunately, 13 sites with fish data were in Fox Run and East Fox Run, upstream from our site HC6, and two sites were located in *Chingaware Run*, upstream from our site 8b.

The MBSS Pilot Study and our eDNA Pilot Study were conducted 30 years apart, so these data sets don't offer the ideal comparison to address the question: "Did eDNA sampling reveal more or few fish species than conventional electrofishing gear?" But since we don't have any other options, we took the plunge.

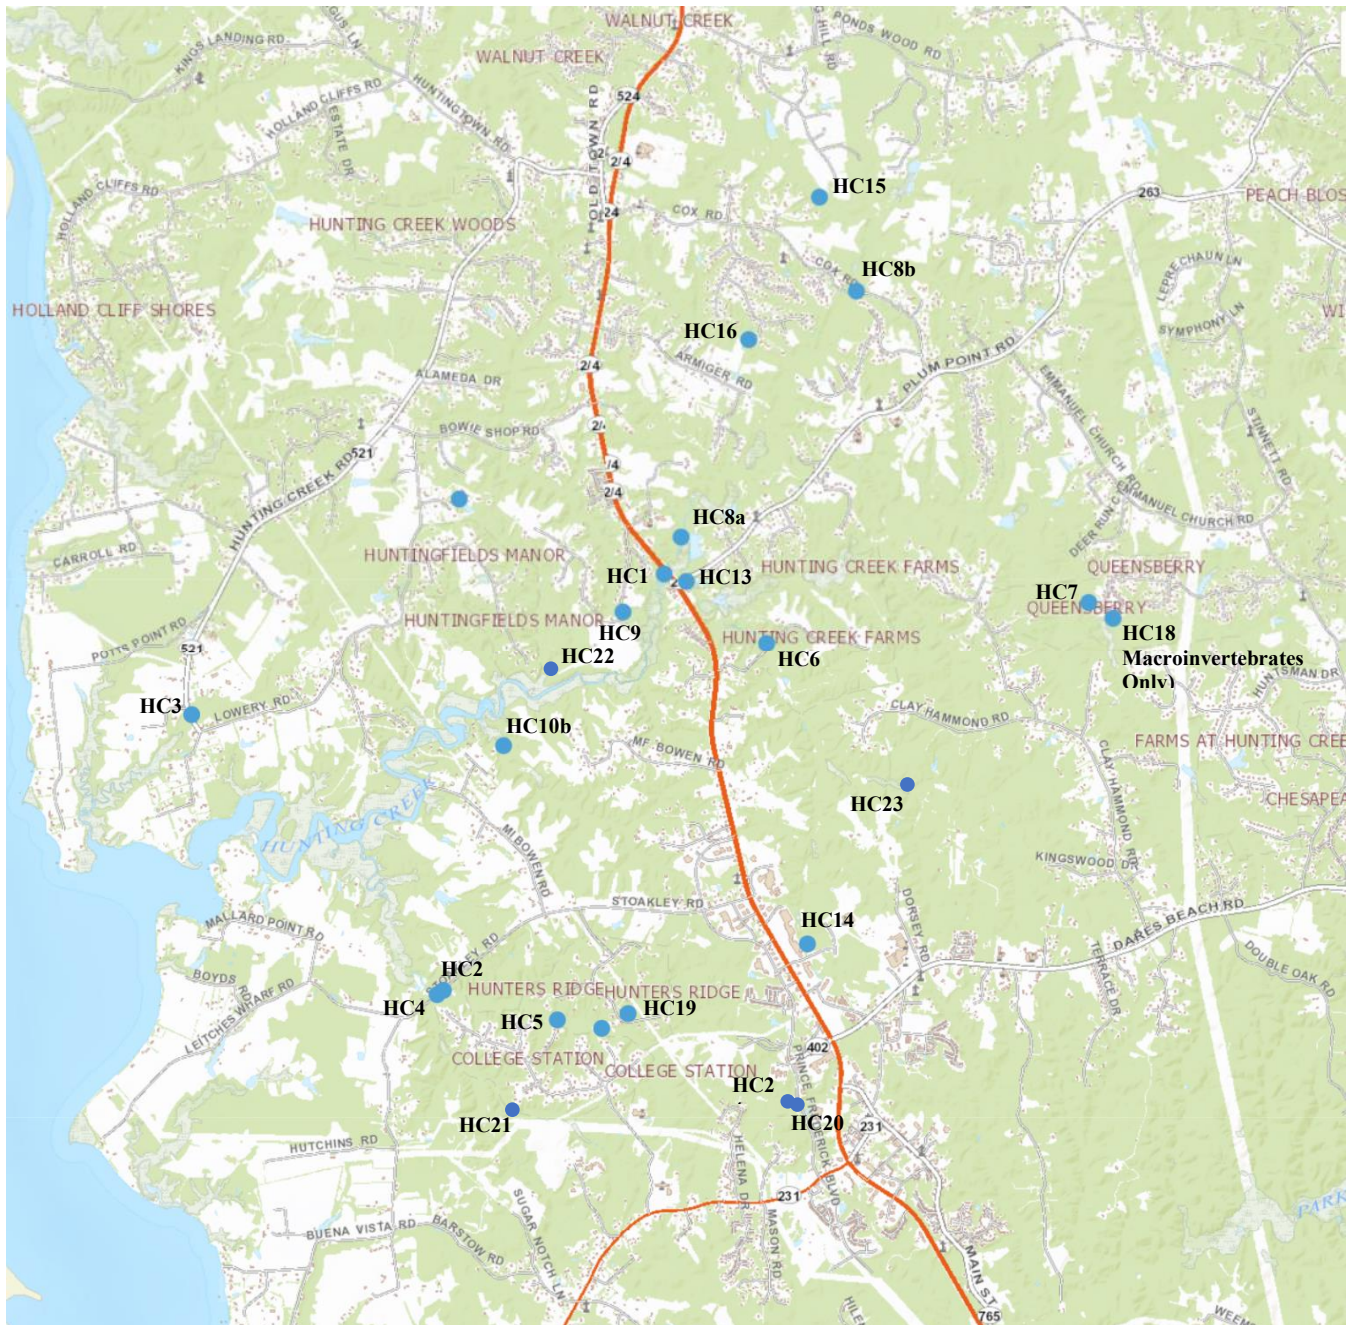
### **Figure F1. Locations of Sites Per Table A2-1 Coordinates**

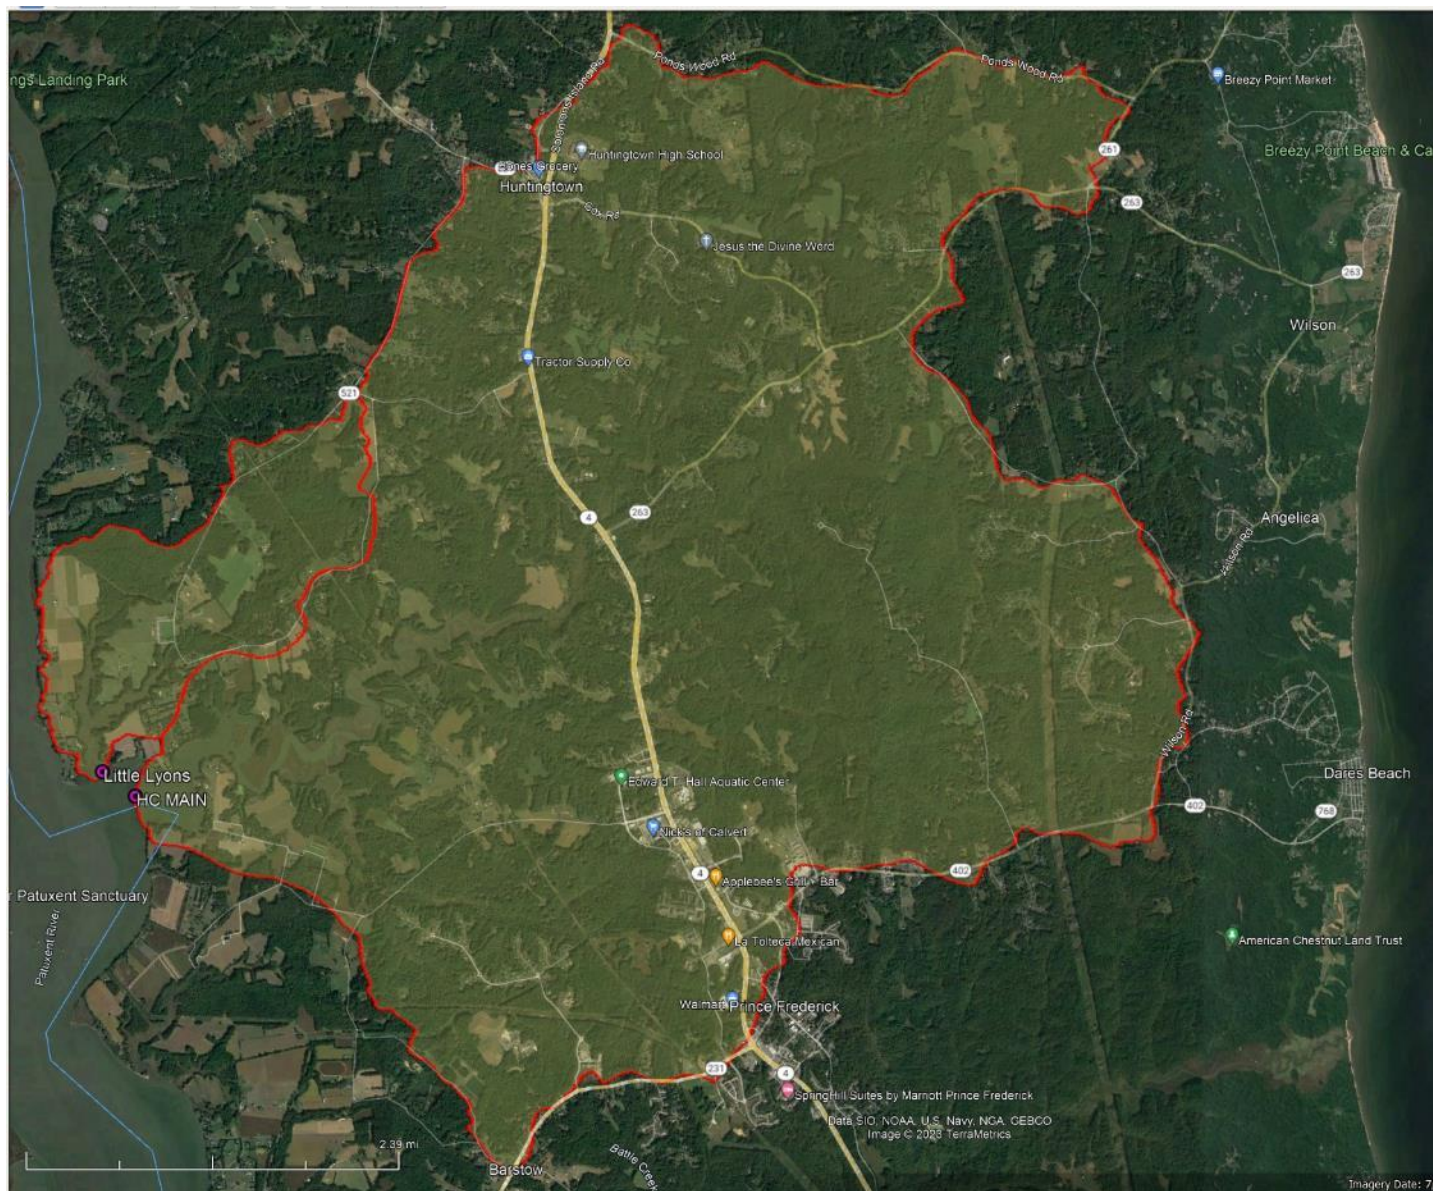
**Figure F3. Hunting Creek Watershed (includes Little Lyons Creek region)**

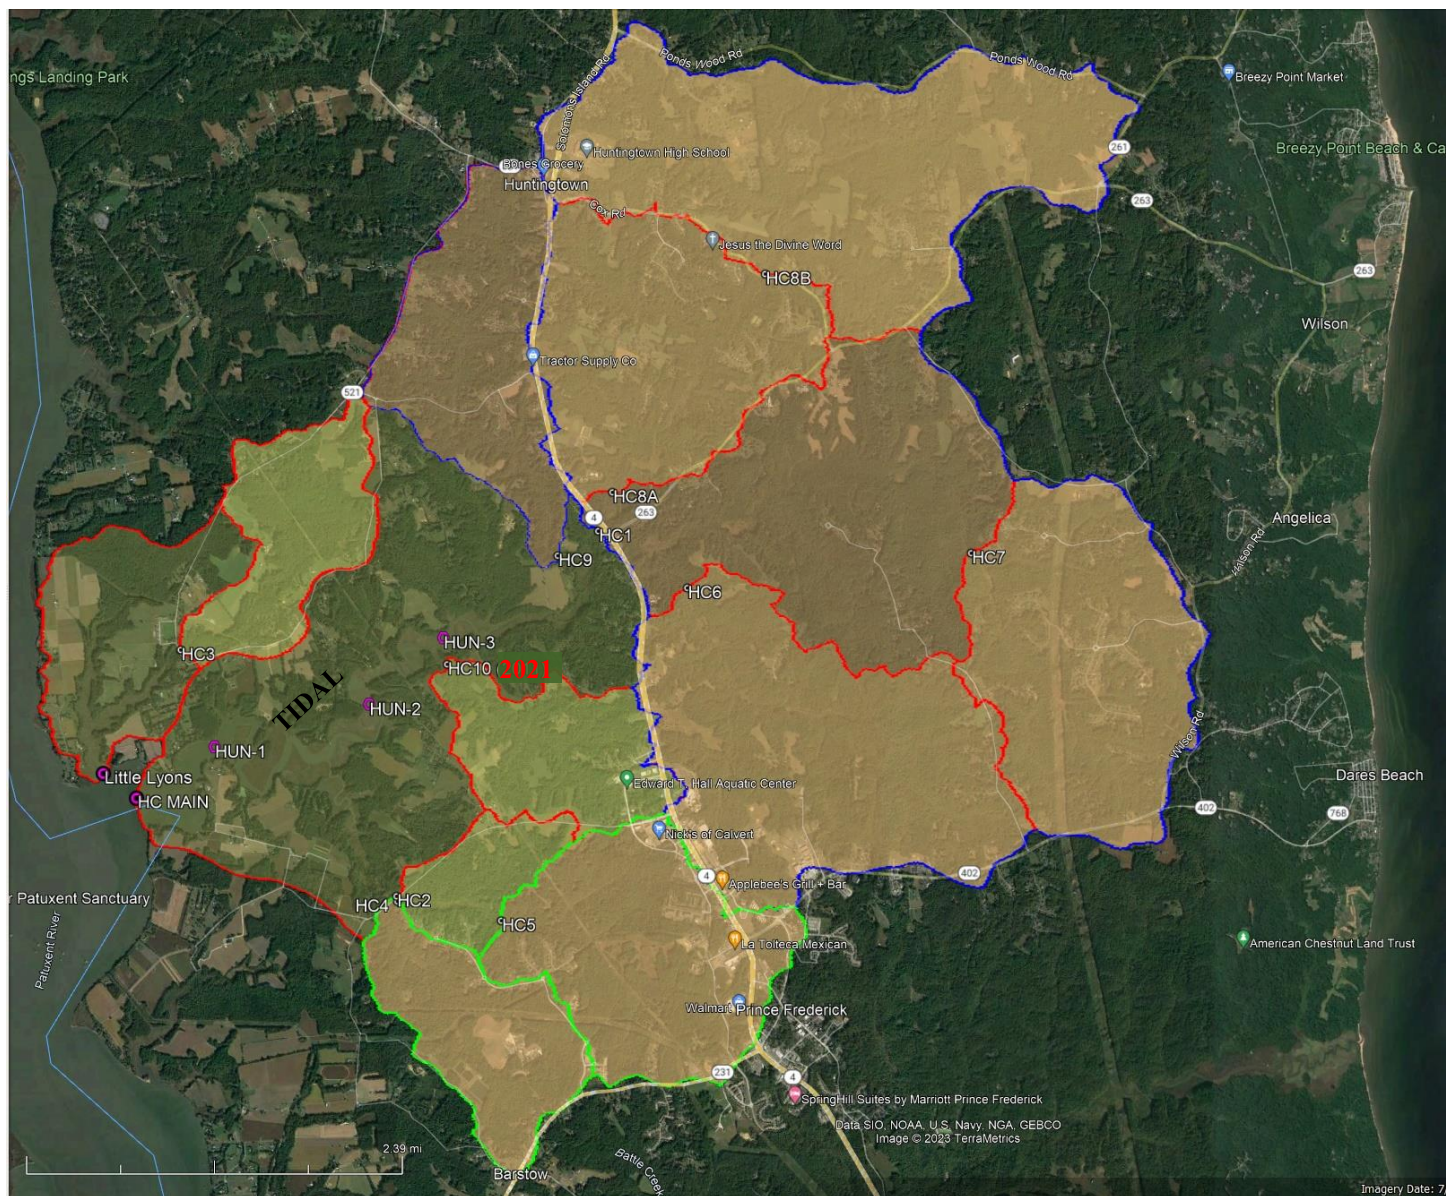
**Figure F4a. Select 2023 Blitz sites overlaid on watershed. The tidal portion of Hunting Creek is from the Patuxent River almost to Rt 4. Note the more transparent shading of tidal extent. Test sites designated by HUN-x are tidal sites tested by CBL.**

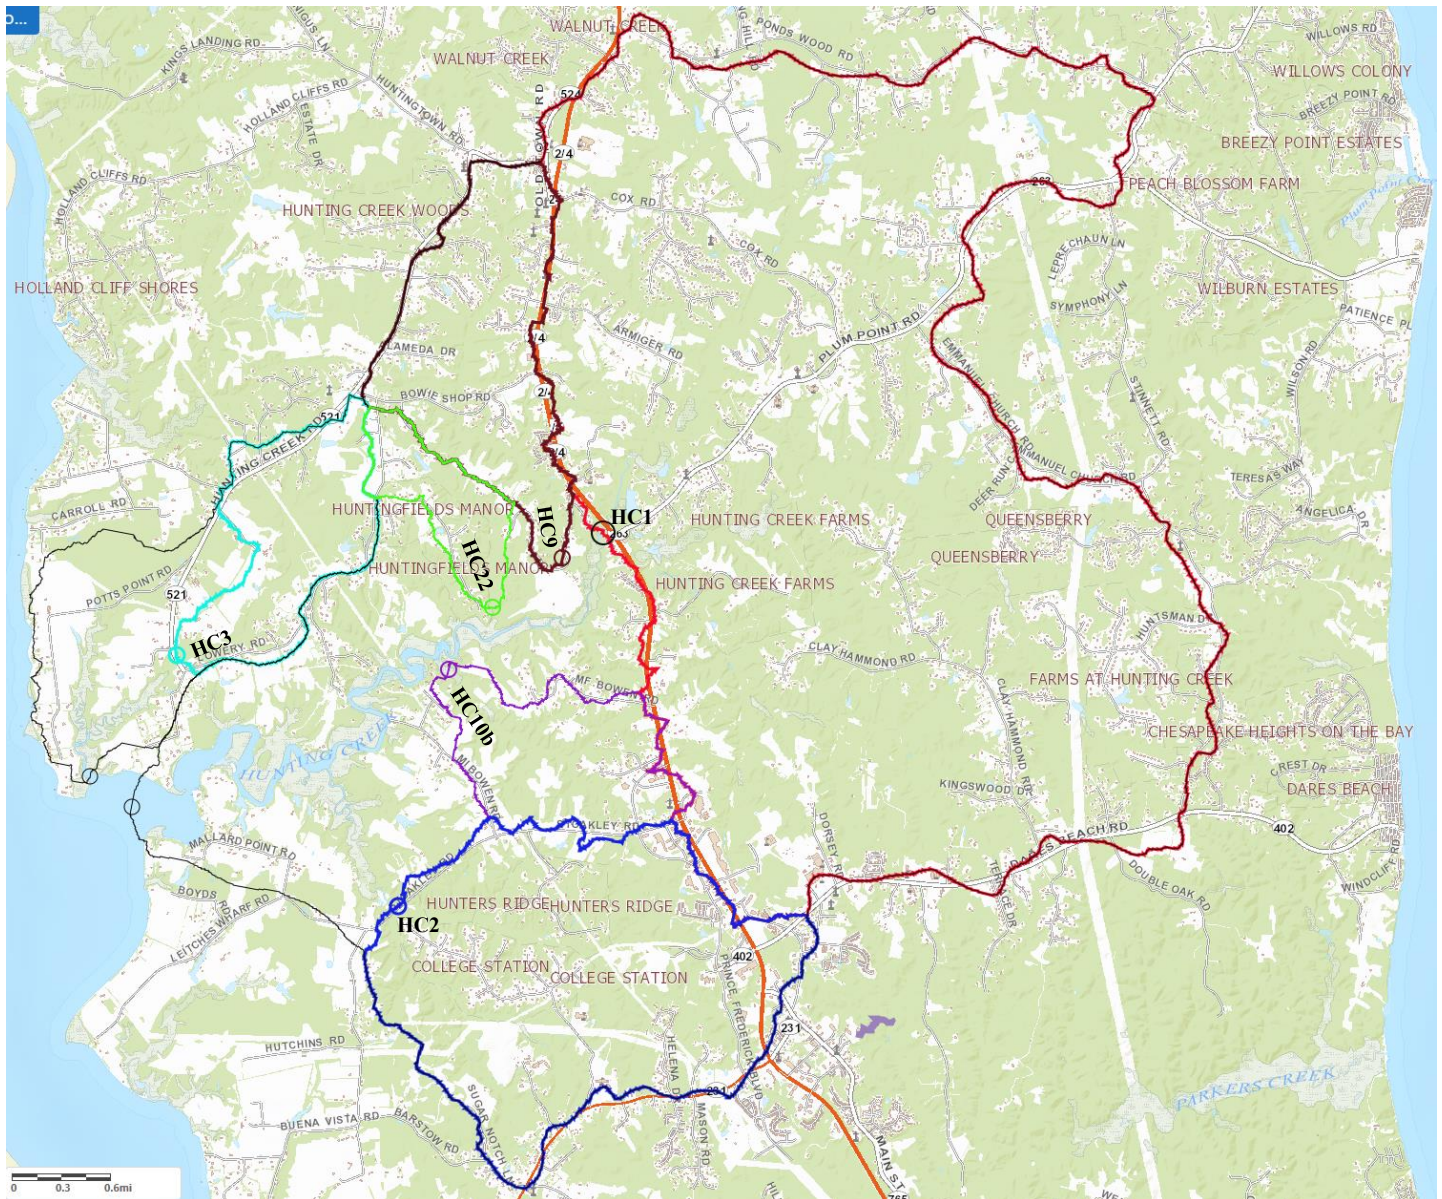
Figure F4b. Major Catchments imported into GIS

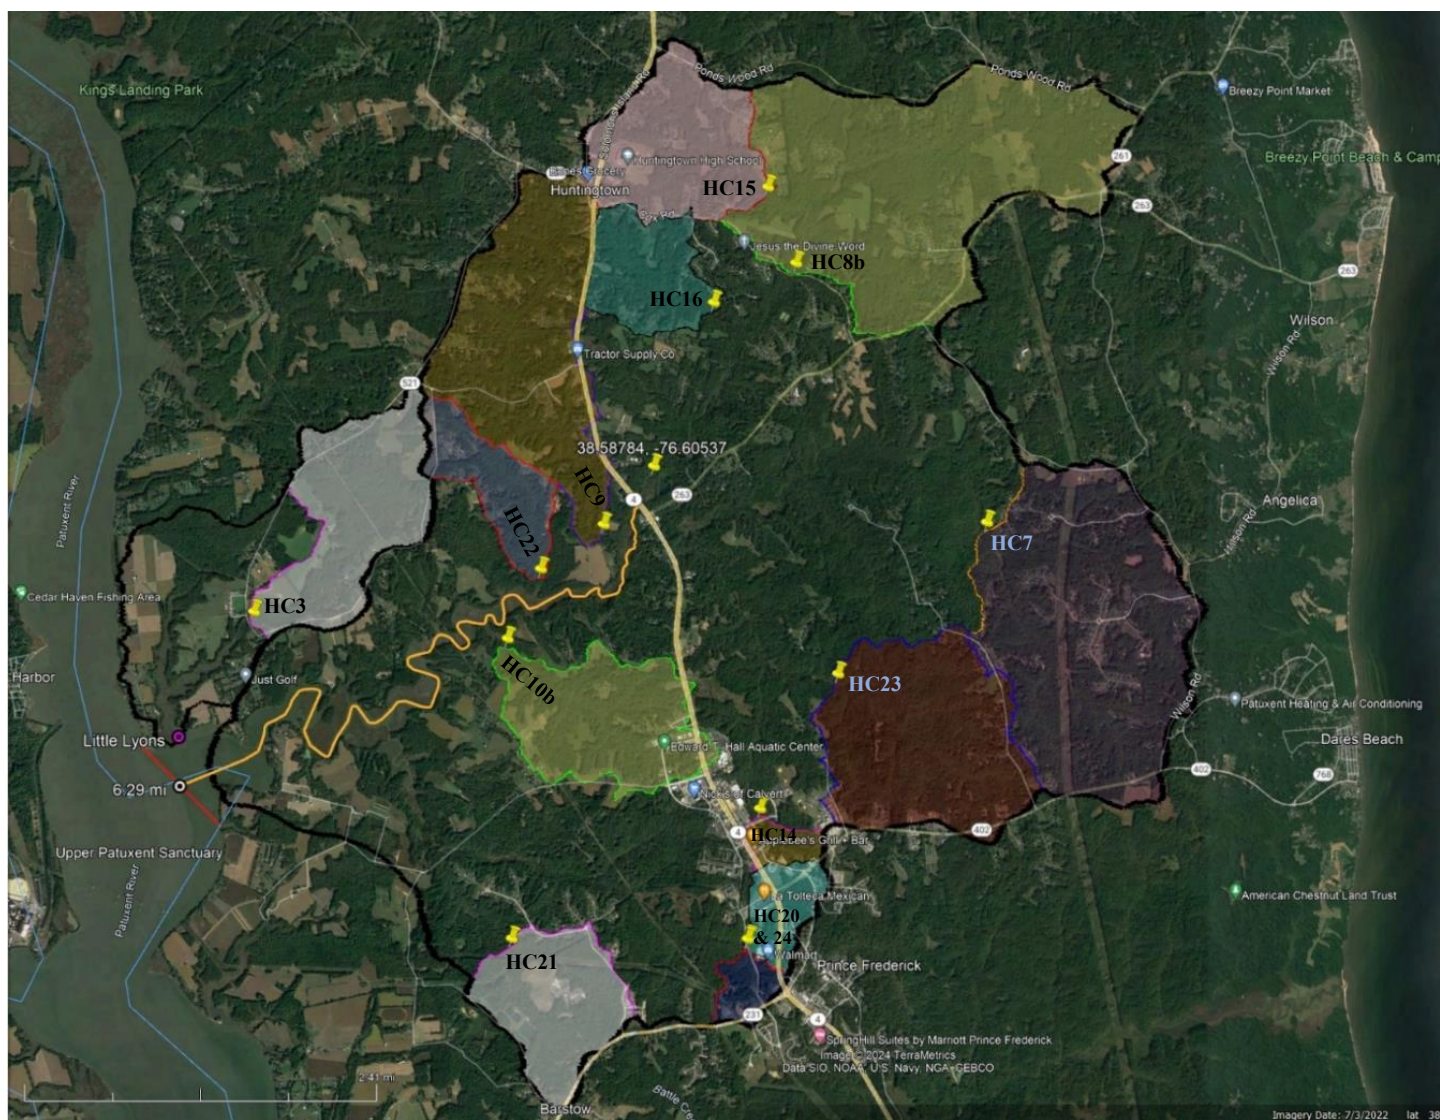
**Figure F5. Outer Catchments**

(Note the border of the Hunting Creek watershed with the Little Lyons Creek sub-watershed is shown in black)
