# Spring Water Quality Blitz in Hunting Creek Watershed on 04/03/21

By Ron Klauda and Bob Estes

On 3 April 2021, members of the FHC conducted the first Water Quality Blitz at several non-tidal stream sites in the Hunting Creek watershed. Monitoring activity in the Hunting Creek watershed coincided with similar efforts also conducted that day in the Parkers Creek and St. Leonard’s Creek watersheds. Water samples collected by FHC volunteers were filtered by Dr. Walter Boynton at the American Chestnut Land Trust office that day and then sent to the Chesapeake Biological Laboratory (CBL) in Solomons, MD for analysis of the key nitrate parameters, NO<sub>3</sub>. Dr. Lora Harris (CBL) graciously loaned the FHC a YSI 556 Multi-Probe System meter and a Marsh McBirney Flo-Mate 2000 current velocity meter for our use on April 3<sup>rd</sup>. With this equipment, we were also able to measure water temperature, conductivity, dissolved oxygen, dissolved oxygen saturation, pH, current velocity, and also calculate flow at several stream sites in the Hunting Creek watershed.

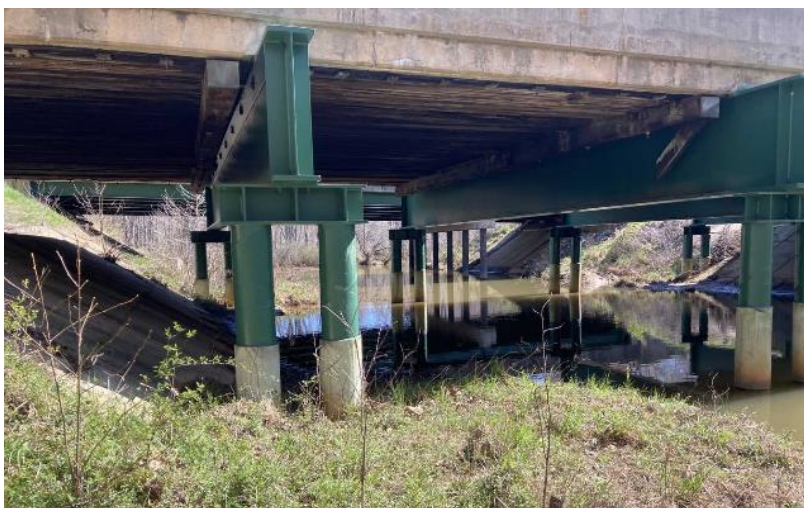
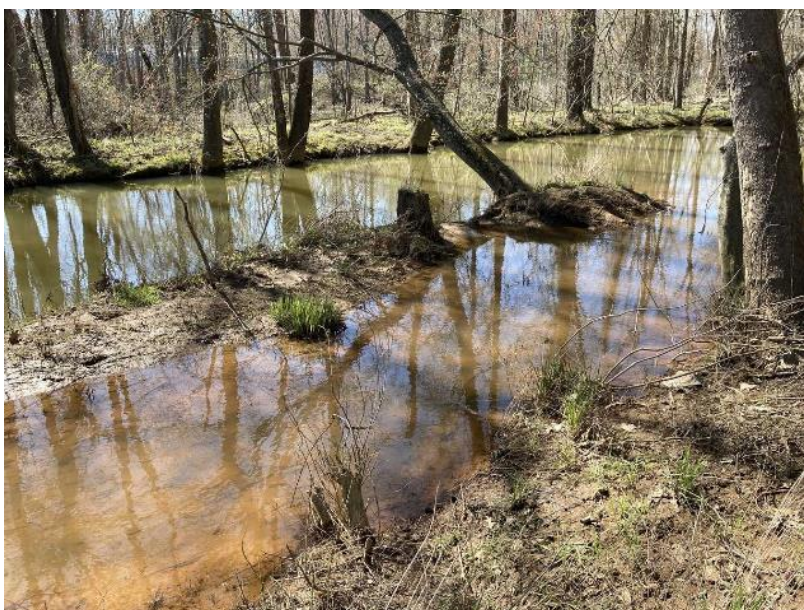
HUNT-1 (Hunting Creek at Route 2/4 bridge; 38.58497, -76.60701): Bob Estes. Becky Hunter

NO<sub>3</sub> = 0.444 mg/L

HUNT-1 looking upstream, 3 April 2021

HUNT-1 looking downstream, 3 April 2021

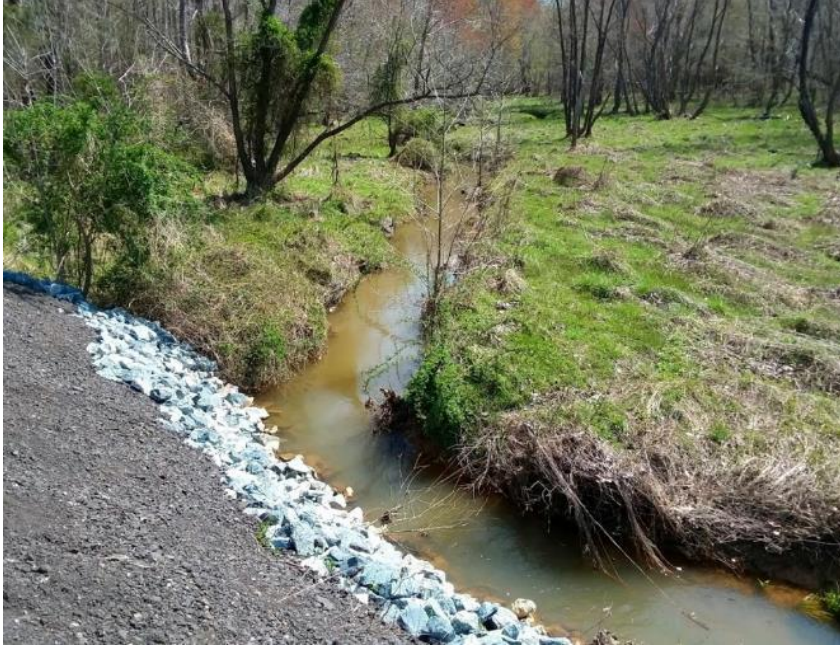
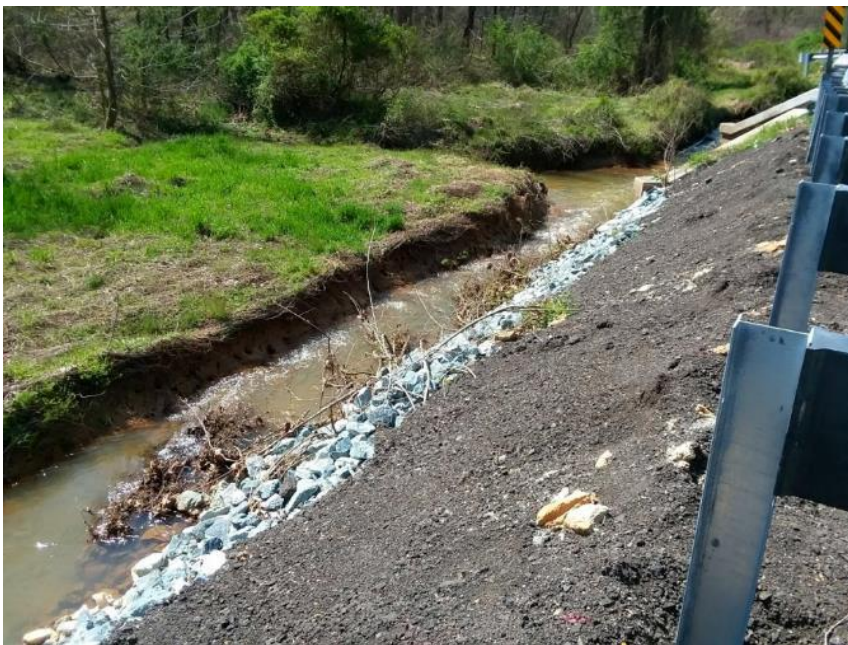
HUNT-2 (Mill Creek at Stoakley Rd. bridge, 38.550892 -76.630039):  
Ron Klauda, Evan Klauda

NO23 = 0.465 mg/L

HUNT-2 looking upstream, 3 April 2021

HUNT-2 looking downstream, 3 April 2021

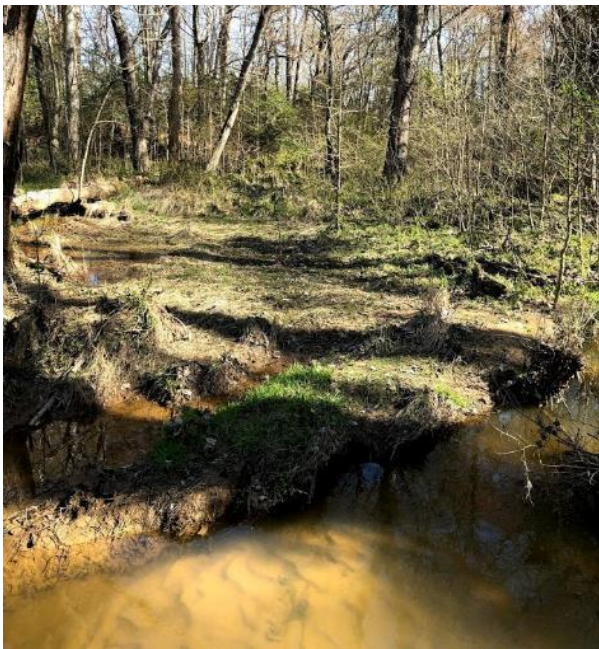
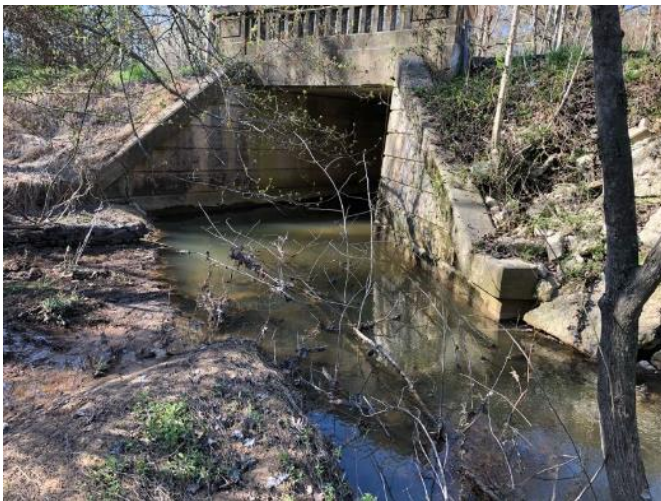
HUNT-3 (Little Lyons Creek at Hunting Creek Rd. bridge, 38.573129 -76.656298): Frank McPhillips, Erin McPhillips, Hali Kilbourne, Nelleke Schijf, Ron Klauda

NO3 = 1.660 mg/L Stream Cross Section Area = 7.30 ft<sup>2</sup>

HUNT-3 looking upstream, 3 April 2021

HUNT-3 looking downstream, 3 April 2021

5. Based on this single sampling event, the HUNT-10 and HUNT-3 sites could be "hot spots" for nitrogen in the Hunting Creek watershed. Additional monitoring in these two streams is needed to confirm these suspicions.

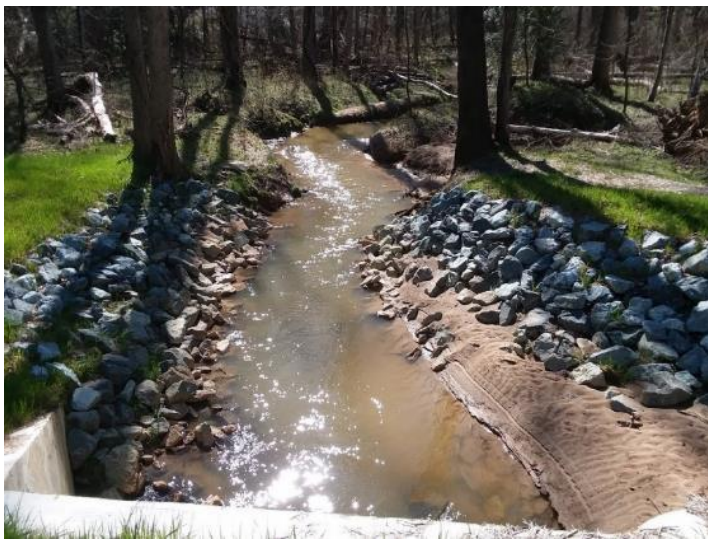
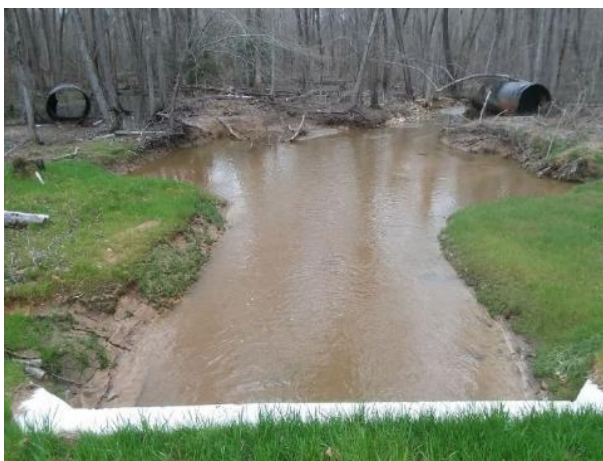
HUNT-6 (UT Hunting Creek at Hunting Farms Lane bridge, 38.579145 -76.596554):  
Ron Klauda, Hali Kilbourne, Nelleke Schijf

NO23 = 0.335 mg/L Stream Cross Section Area = 6.82 ft<sup>2</sup>

HUNT-6 looking upstream, 3 April 2021

HUNT-6 looking downstream. 3 April 2021

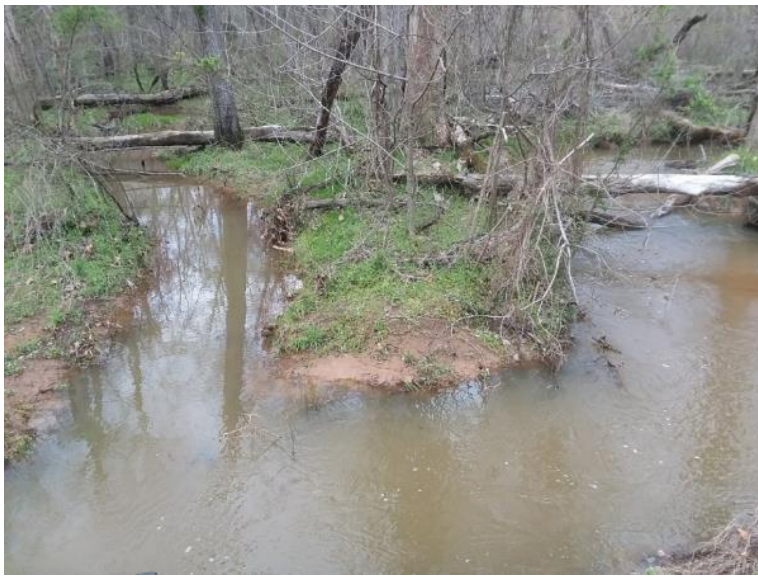
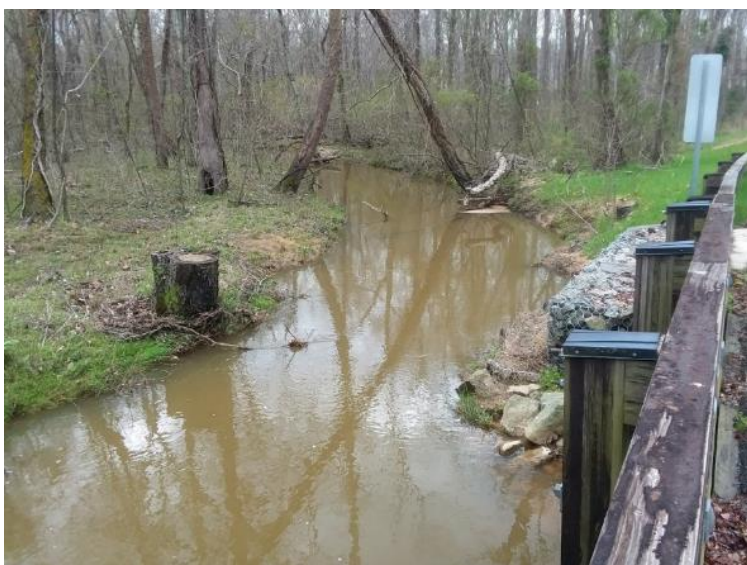
HUNT-8b (Sewell Branch at Cox Rd. bridge, 38.607864 -76.586875):  
Hali Kilbourne, Ron Klauda, Nelleke Schijf

HUNT-8b looking upstream, 3 April 2021

HUNT-8b looking downstream, 3 April 2021

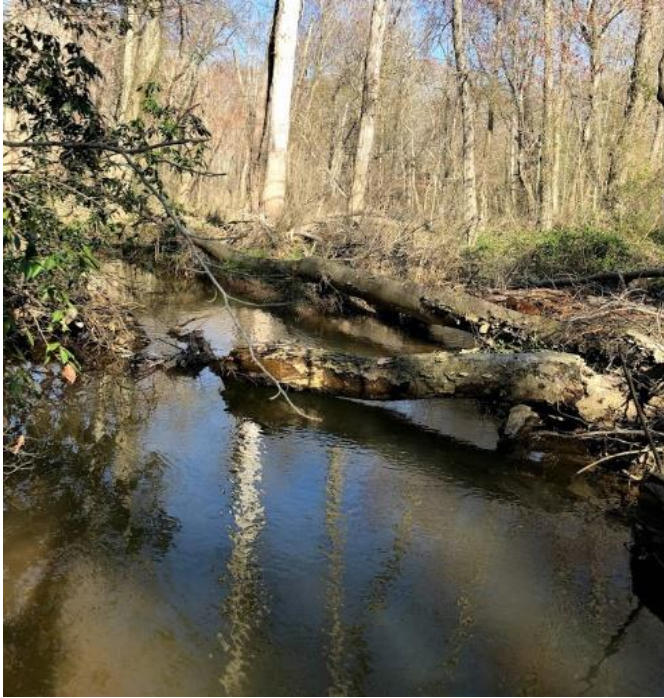
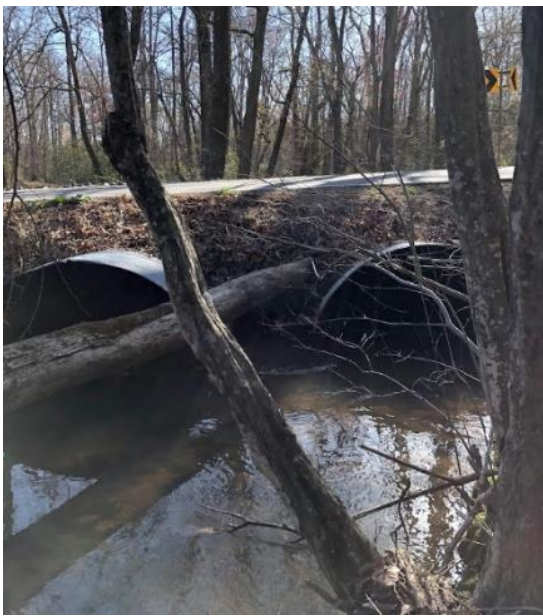
HUNT-9 (Reits Branch at Walton Rd. bridge, 38.581751 -76.611328):  
Frank McPhillips, Erin McPhillips

NO<sub>3</sub> = 0.712 mg/L

HUNT-9 looking upstream, 3 April 2021

HUNT-9 looking downstream, 3 April 2021

4. The less good news is that 3 of the 10 sites had NO<sub>2</sub>-N concentrations that were above the nitrogen standard. However, at 0.712 mg/L, the HUNT-9 site (Reits Branch) was only slightly above the 0.7 mg/L standard. Of more concern is that the HUNT-10 site in Fox Point Creek (1.093 mg/L) exceeded the standard by 56%. The NO<sub>2</sub>-N concentration at HUNT-3 site in Little Lyons Creek (1.660 mg/L) was more than twice as high as the nitrogen standard, exceeding it by 137%. It should be noted that the HUNT-10 site was freely flowing out into toward Hunting Creek. A subsequent excursion up Fox Point creek during a higher tide revealed that the test point was not beyond the reach of the high tide. A site further upstream of the test site was identified as well beyond the high tide. This site will be used for future tests subject to land owner permission. The location of the future site is shown in Appendix 1 figure A10.

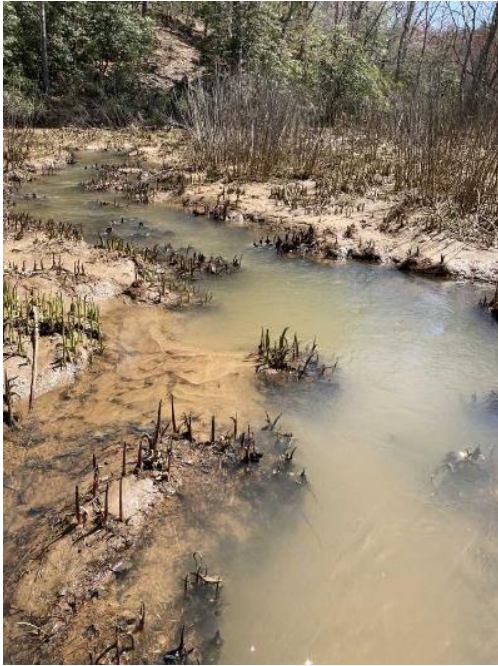
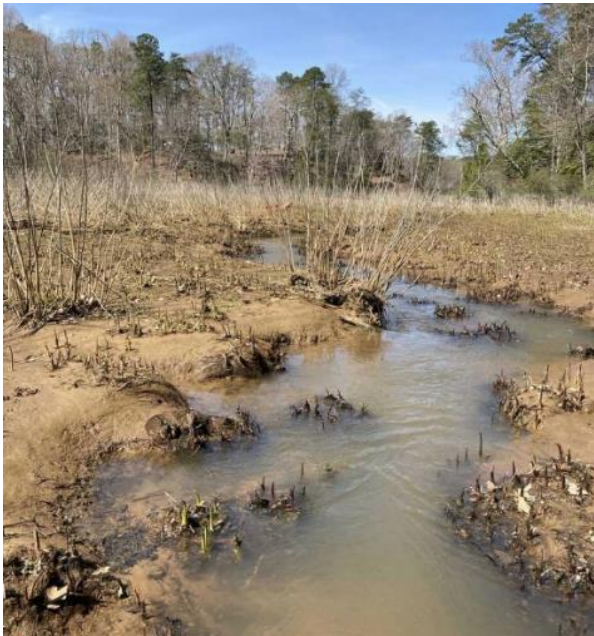
HUNT-10 (Fox Point Creek upstream from confluence with Hunting Creek,  
38.57192, -76.62436): Bob Estes

This site is not near a bridge or other landmark. Accessed via kayak and waders. Note that at the time the sample was taken it was low tide and water was flowing in a manner typical of a small stream. High tides do reach this point. Points further upstream require a land entrance over private property.

NO23 = 1.093 mg/L

\_HUNT-10 looking upstream, 3 April 2021

HUNT-10 looking downstream, 3 April 2021

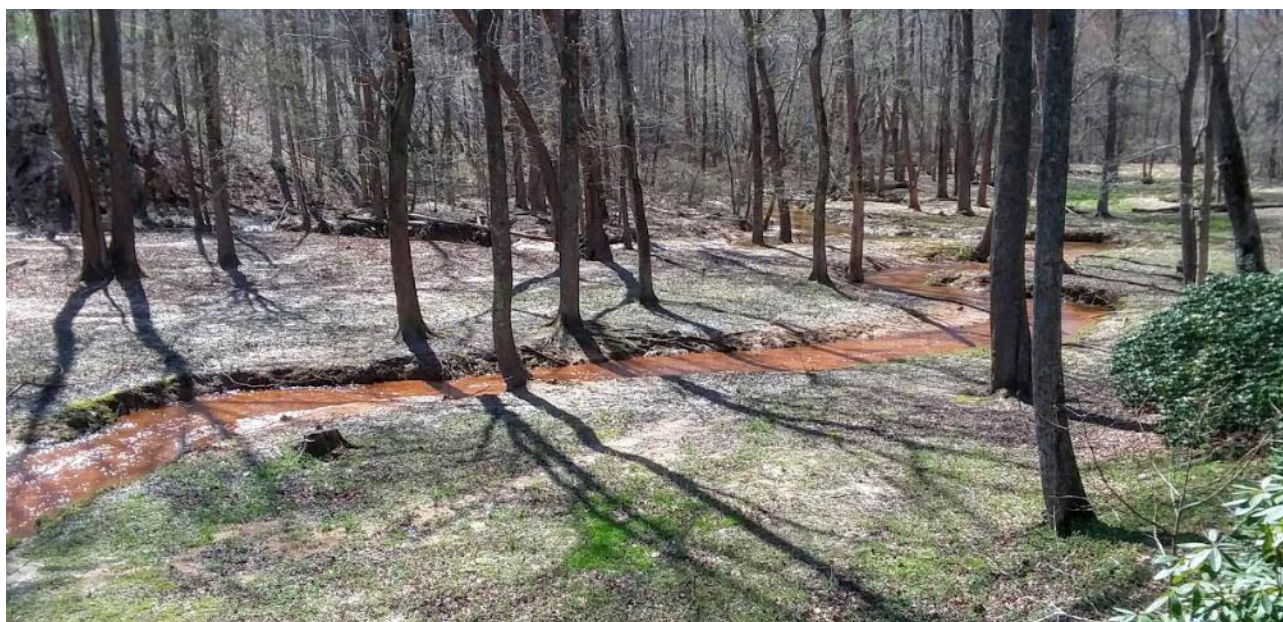
HUNT-12 (Mill Creek behind 650 Willow Way, Hunters Ridge, 38.547643 -76.613125):  
Hali Kilbourne, Ron Klauda, Nelleke Schijf

Stream Cross Section Area = 4.04 ft<sup>2</sup>

HUNT-11 (foreground) and HUNT-12 (background), 3 April 2021

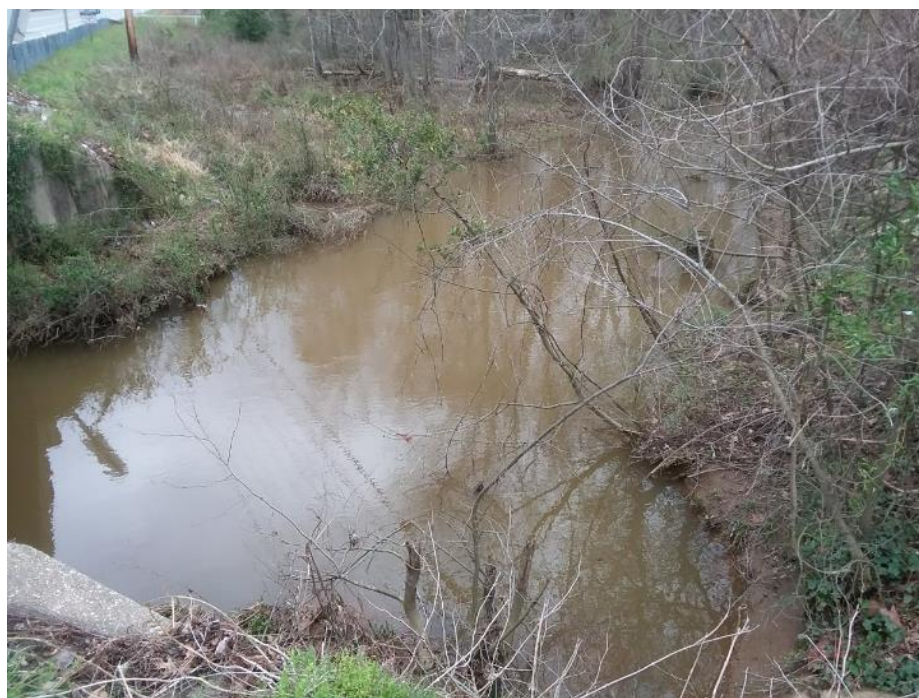
HUNT-13 (Hunting Creek just upstream from Plum Pt. Rd. bridge, 38.584290 -76.604860):  
Hali Kilbourne, Ron Klauda, Nelleke Schijf

HUNT-13 looking downstream from Plum Pt. Rd. bridge, 3 April 2021
